Construction Fixed: Conquering Home Performance Errors

2017 RESNET

Brian Lieburn

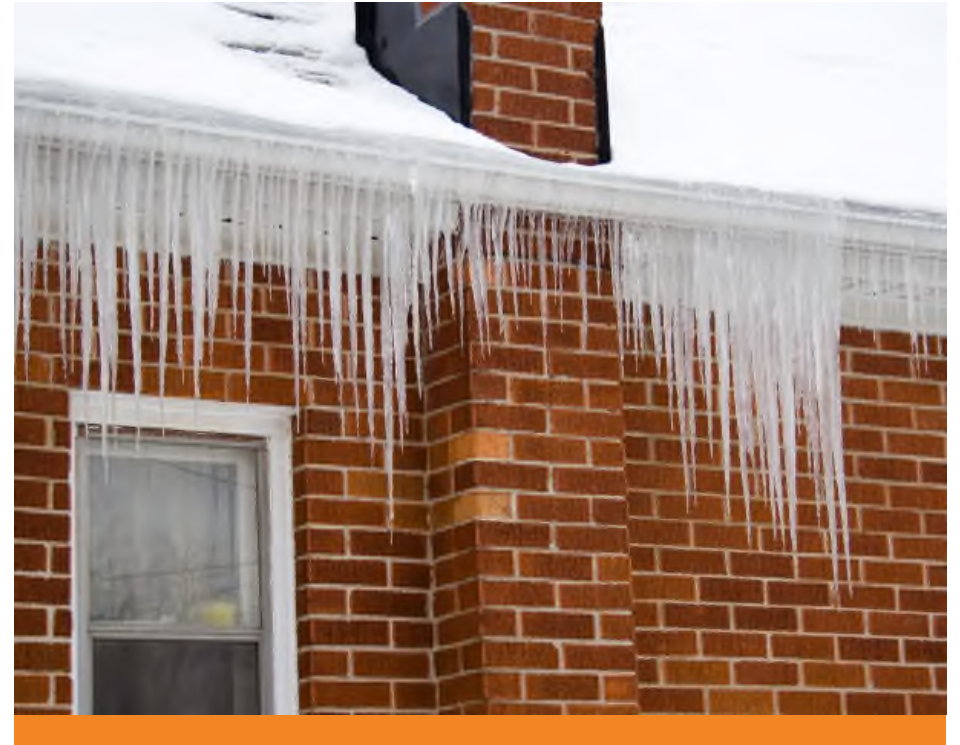
Adequate Insulation at Truss/Rafter Heel

- Energy loss
- Ice Dams

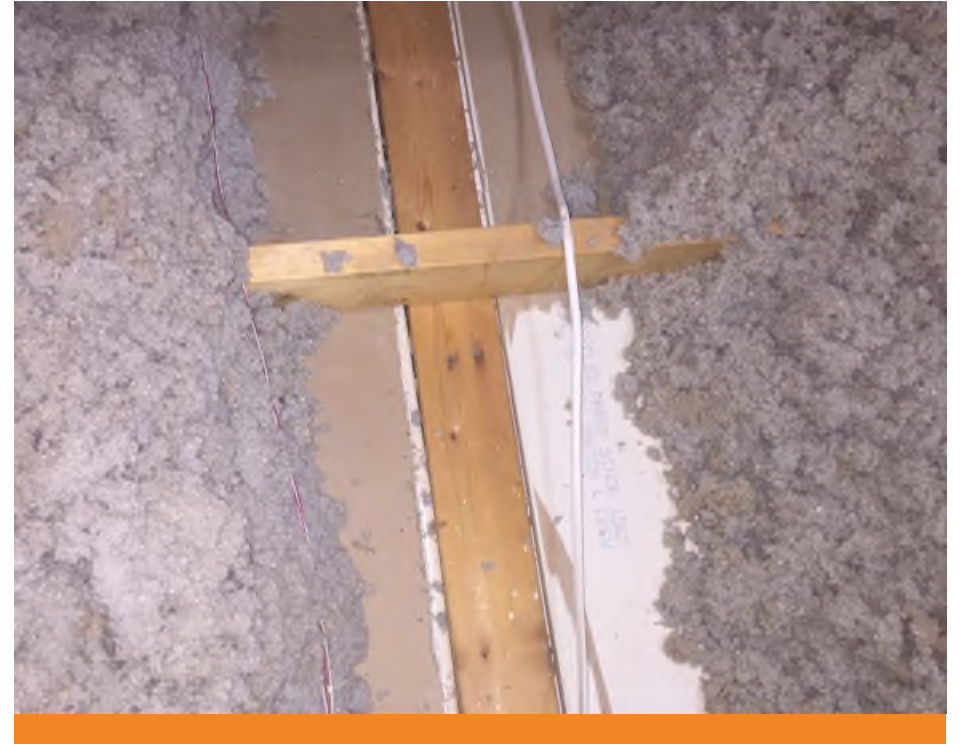
Top Plate Air Sealing

- Significant source of energy loss*
 - *Wolf, Dave; Characterization of Air Leakage in Residential Structures
- Durability issues

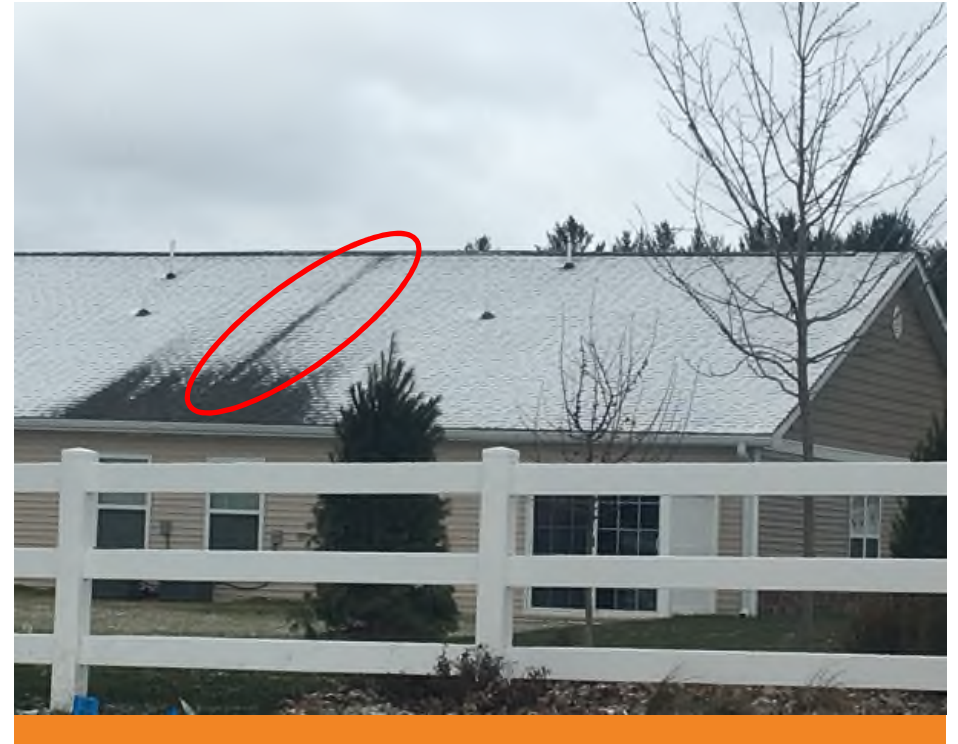
Common Wall Heat Loss

- Adjacent walls each insulated with R-13 FG that only has 5 sides of contact
- Adjacent trusses have 2 layers of 5/8" Type "X" gypsum per fire code
- Allows heat loss through common walls to stack right up to roof deck
 - Energy loss
 - Condensation on underside of roof sheathing

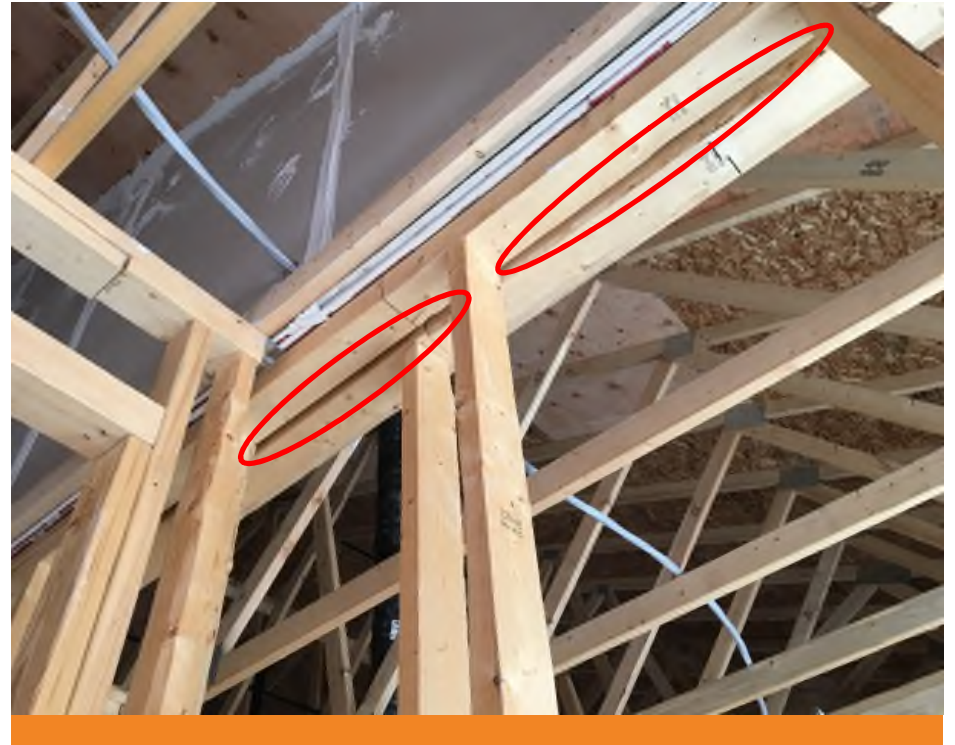
Common Wall Heat Loss

- Air seal to prevent heat loss from conditioned common wall area to unconditioned attic area
- Fireblocking is required!!
- Air barrier on the back side of these walls.

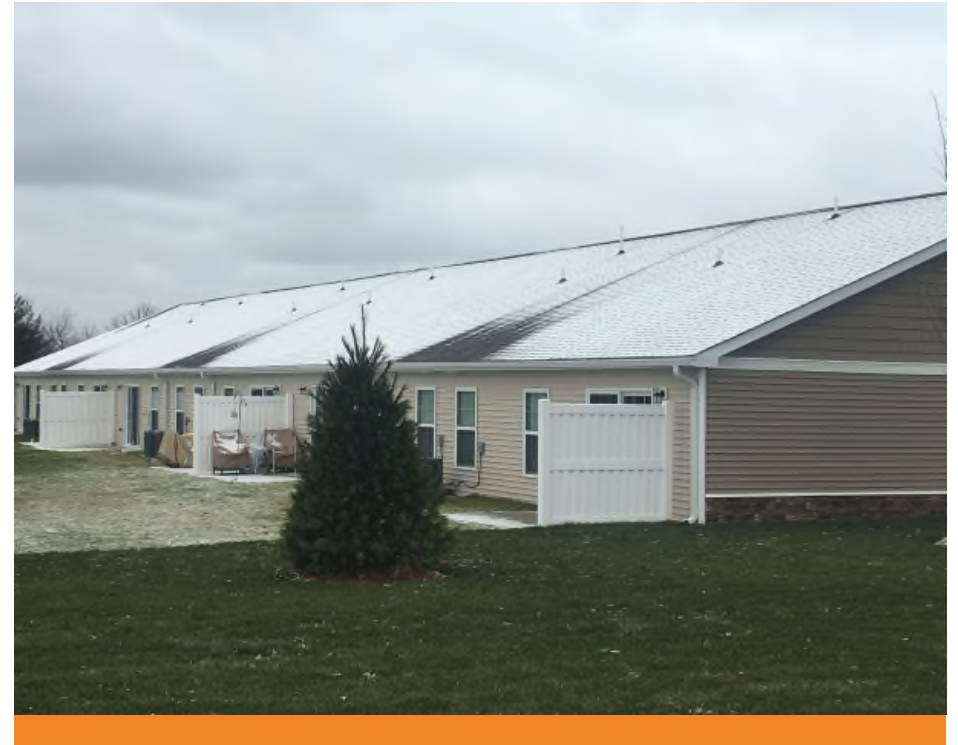
Venting to Soffits

- Allows warm humid air to be pulled back into attic space

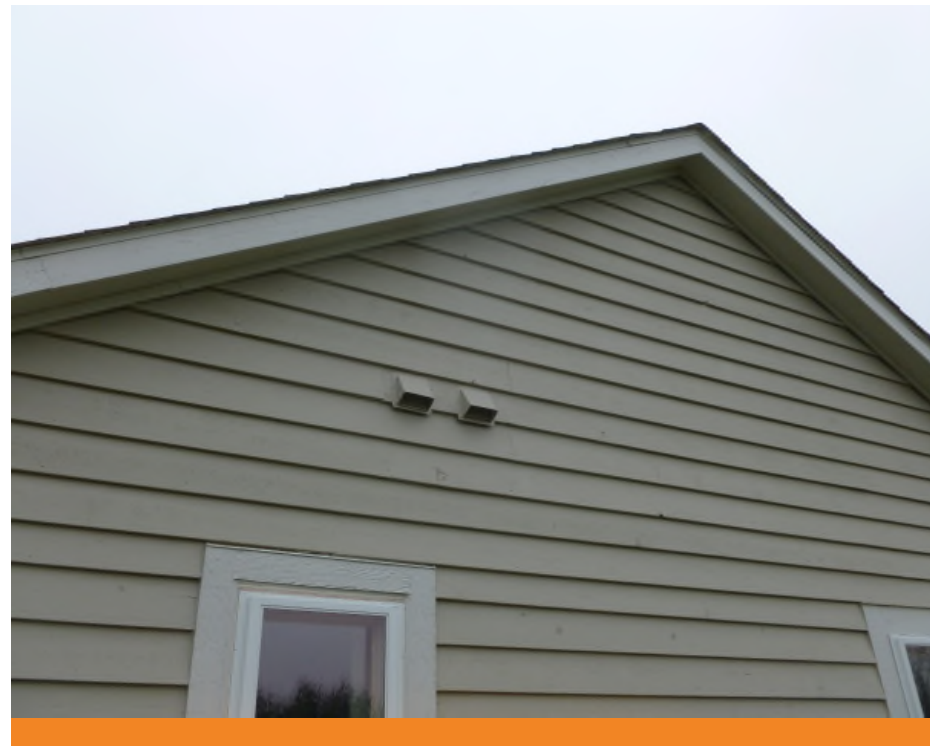
Venting to Soffits

- Don't exhaust through soffit

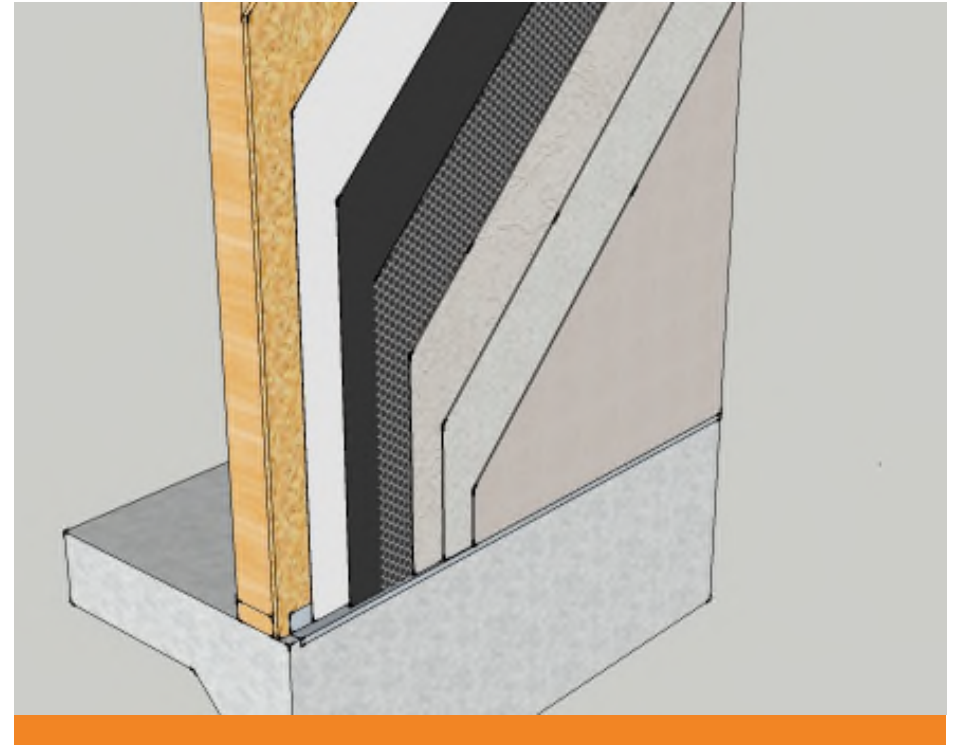
Inward Vapor Drive

- Rain causes cladding to absorb water
- Sun causes drying in both directions
 - Outward Good
 - Inward Bad -
- Temperature drop in evening causes condensation on sheathing surface

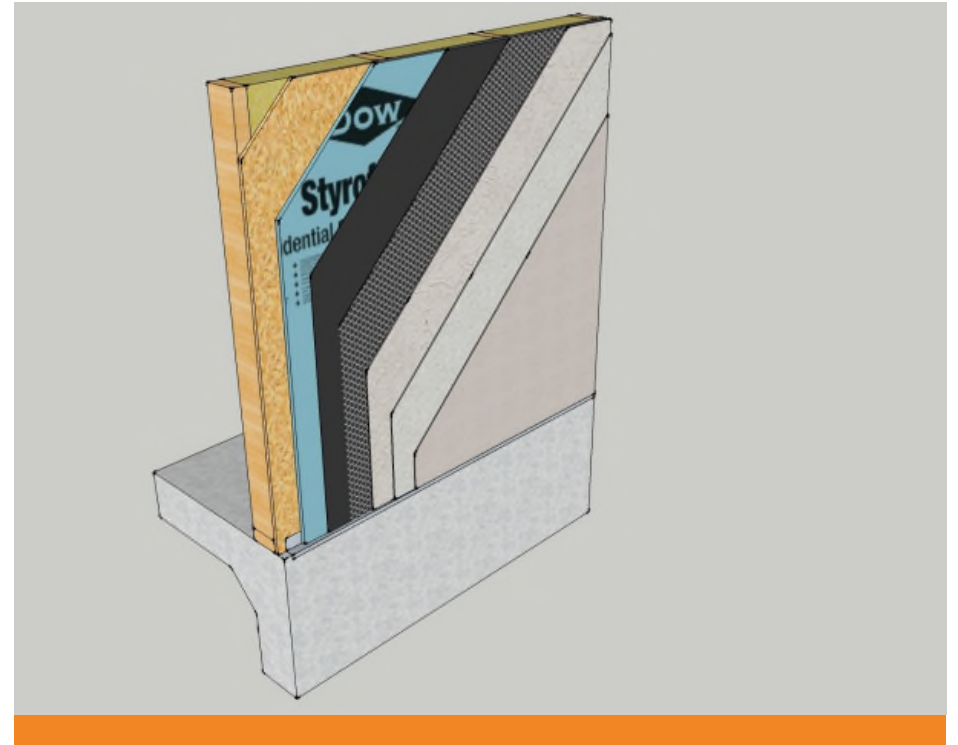
Inward Vapor Drive

- Ventilation space
- Low perm CI or WRB

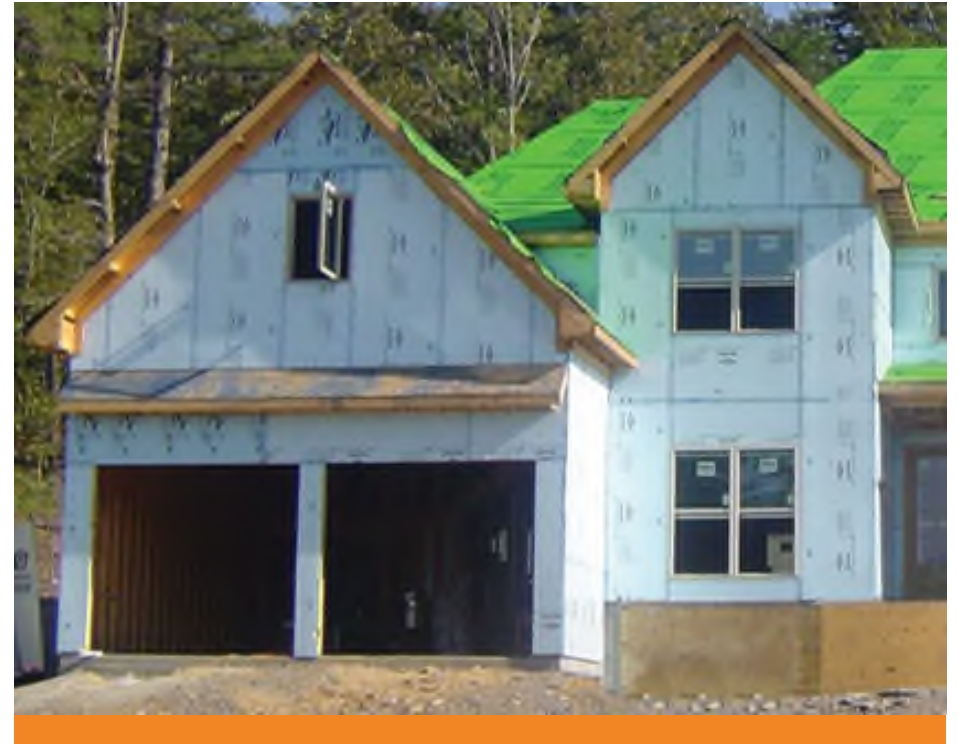
FROG's (Finished Rooms Over Garages)

- Difficult to keep comfortable
 - Why?
- Surrounded by exterior on 5 of 6 sides
- Long duct runs
- Inadequate Insulation
 - Dropped ceilings in garages
 - Heat runs
 - Plumbing chases
 - Knee walls
 - Sloped rafters

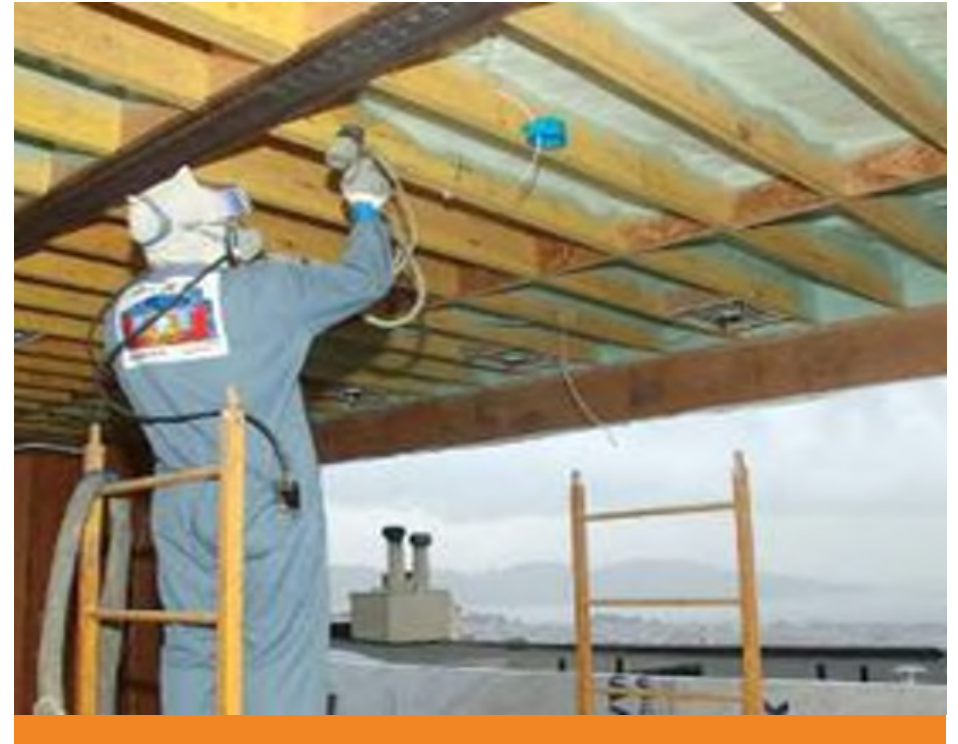
FROG's (Finished Rooms Over Garages)

- Floor
 - Spray foam in floor
 - Continuous insulation on underside of joists
 - Hardwood floor issues
 - Completely fill void with insulation
- Ducts
 - Manual J, D, & S
 - Commissioning
- Rafters
 - Fur down to achieve R-value

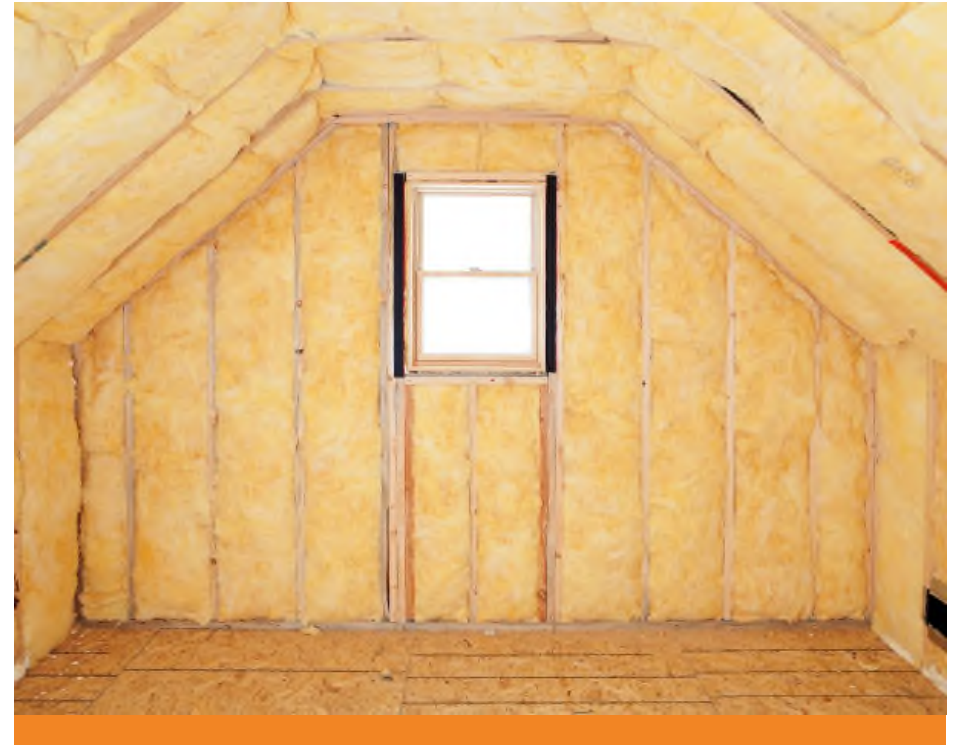
Knee Walls

- Comfort Issues
- Energy loss

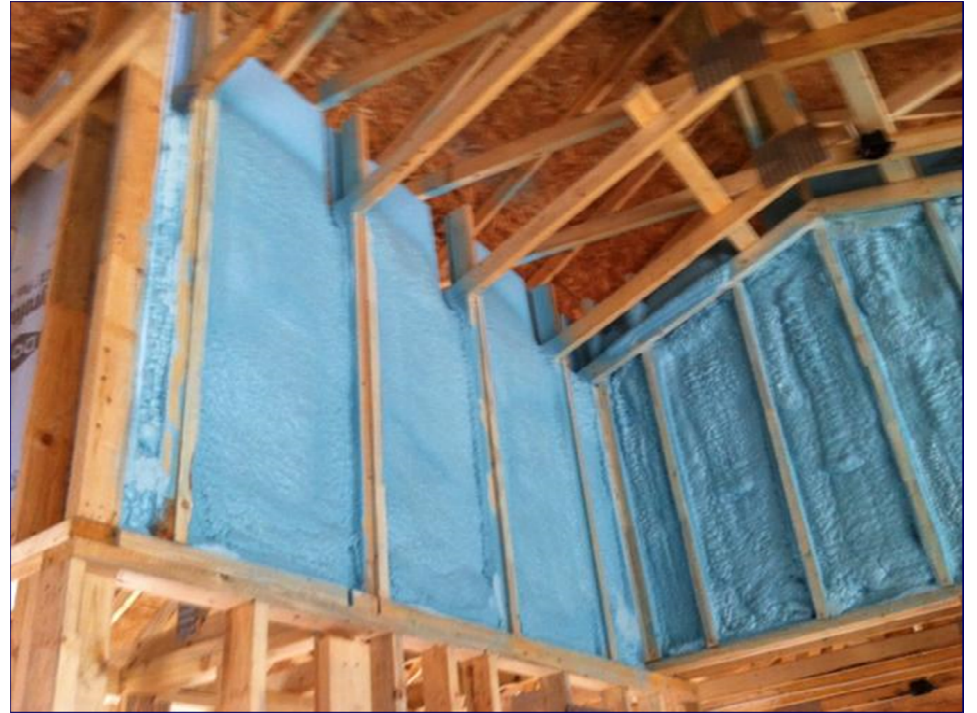
Knee Walls

- Spray foam
- Air Barrier on exposed side of attic
- Continuous insulation on exposed side of attic

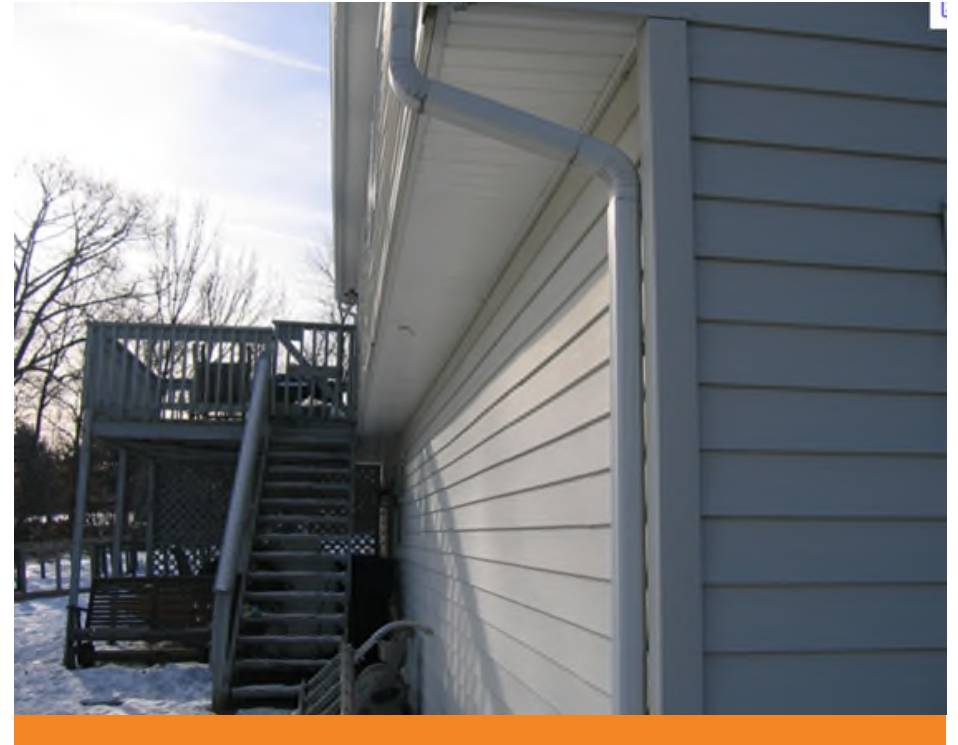
Cantilevers

- Frozen pipes
- Continuity of air barrier
- Difficult to insulate effectively

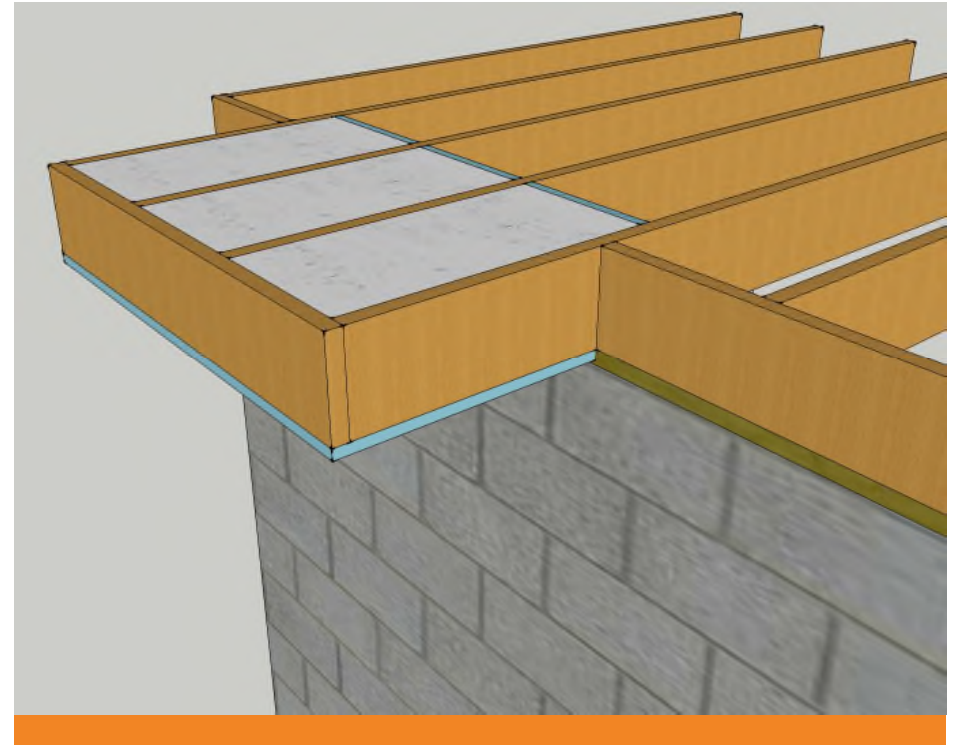
Cantilevers

- Spray foam
- Dense pack insulation
- Air barrier all six sides insulation
- Continuous insulation on underside of joists

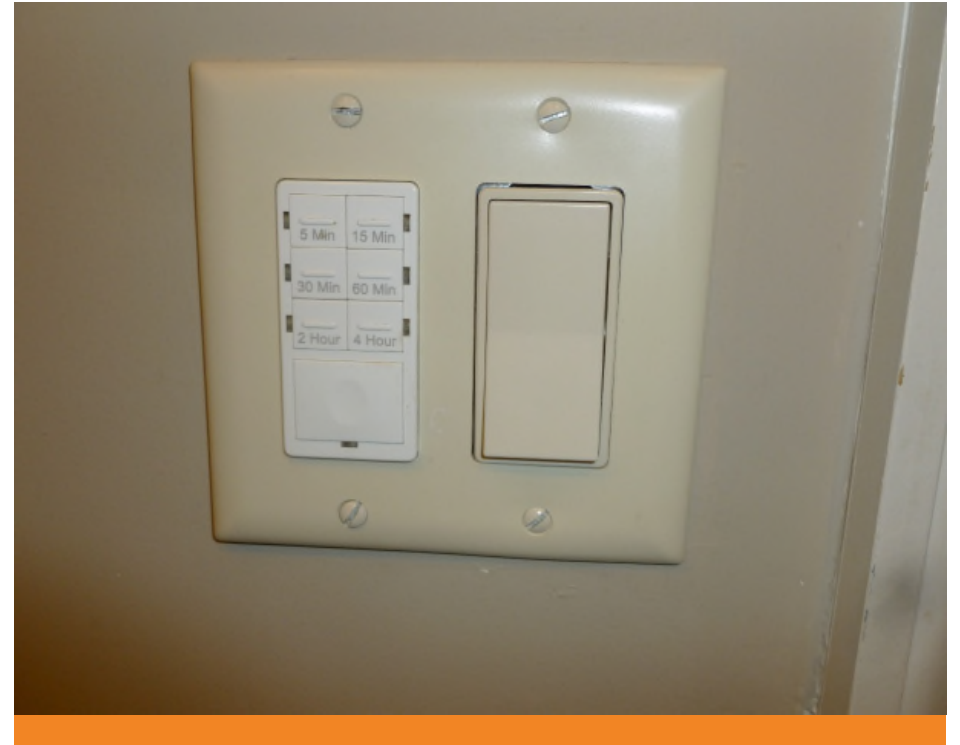
Bathroom Condensation

- Properly sized bath fan
- Adequate bath fan exhaust duct
- Humidistat control
- Bath fan timer
- Air seal
- Insulation
- Occupant education

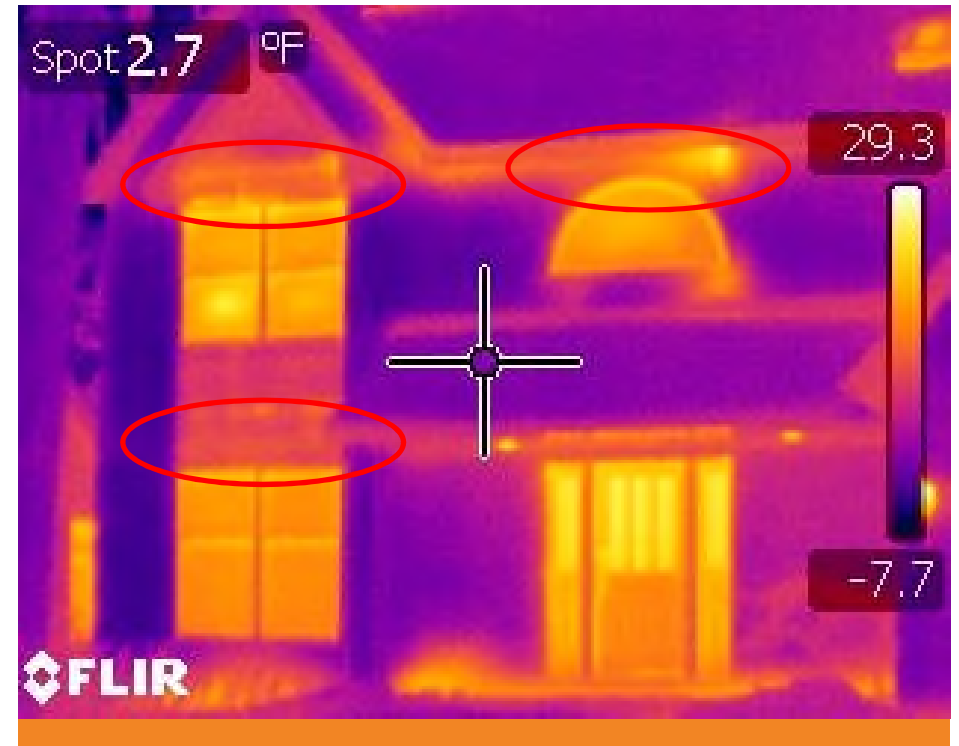
Headers

- Inadequate insulation
- Fiberglass compressed in headers has reduced effective R-Value

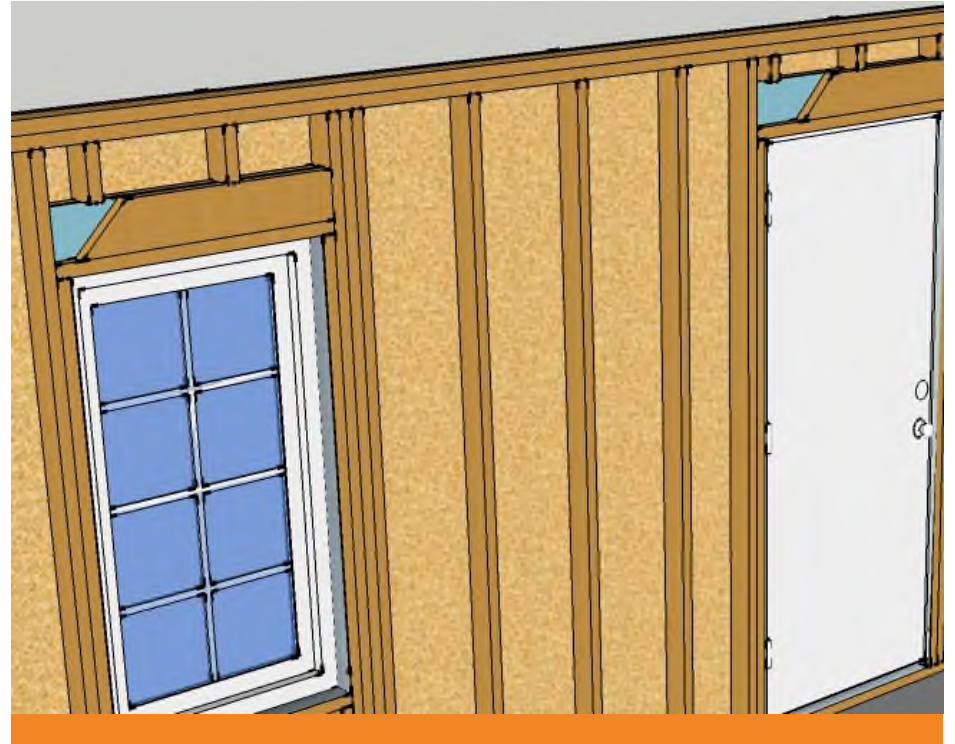
Headers

- Relocate to rim joist
- Size minimal
- Use higher R-value insulations
- Continuous insulation on exterior

OSB	1/2" XPS
2x4	R-3.5	R-6
	OSB + FG	2" XPS
2x6	R-10	R-13.5

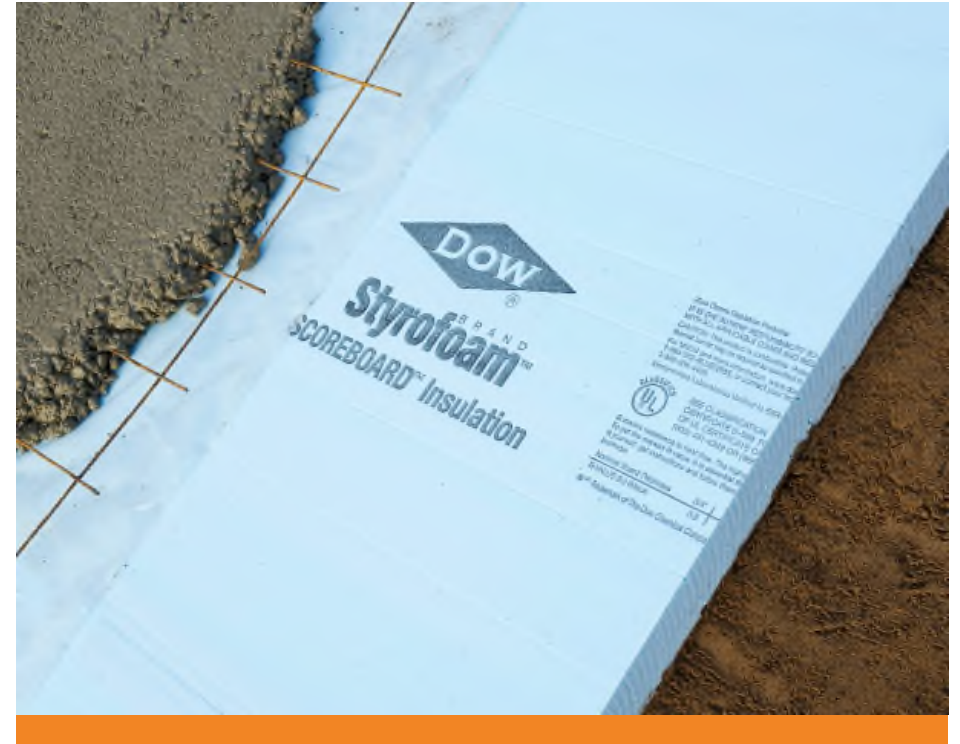
Basement Floor Insulation

- **CONDUCTIVE HEAT LOSS:**
- Uninsulated Basement Floor:
 - 1000 SFT X (65-54)/ R-1 = 11,000 BTU
 - Insulated Basement Floor (R-10 XPS)
 - 1000 SFT X (65-54)/ R-11 = 1,000 BTU
- **Largest uninsulated surface left in the home!**
